Navajo Abandoned Uranium Mine

Site Screen Report

Rocky Flats No. 1 AUM Site

Weston Solutions, Inc.

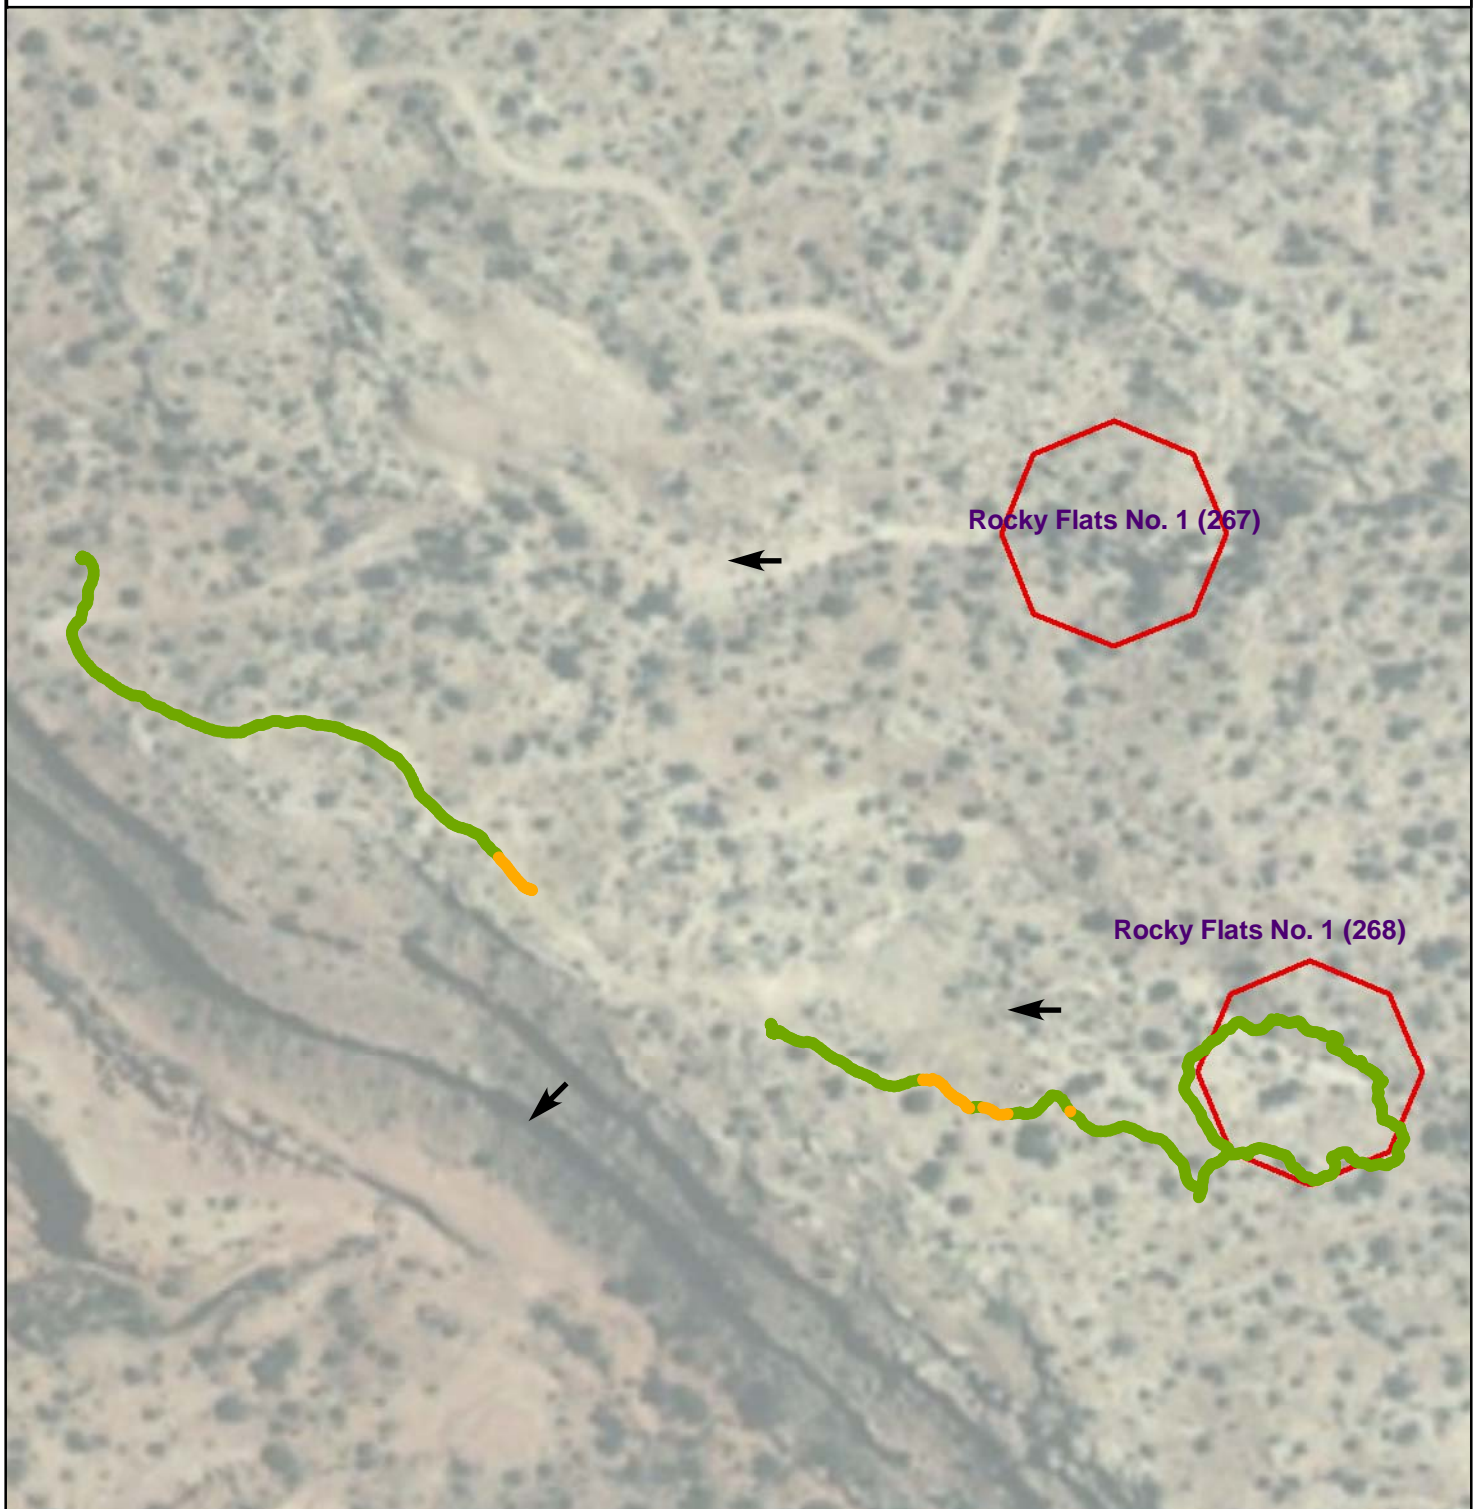
A total of 1,002 gamma radiation measurements were collected from the mine site, ranging from 5,703 cpm to 79,866 cpm. The measurements are represented in Figures 8 and 9.

**Figure 8 - Gamma Radiation Measurements, Above Two Times Background
Rocky Flats No. 1 (268)
Beclabito Chapter, Navajo Nation, Arizona**

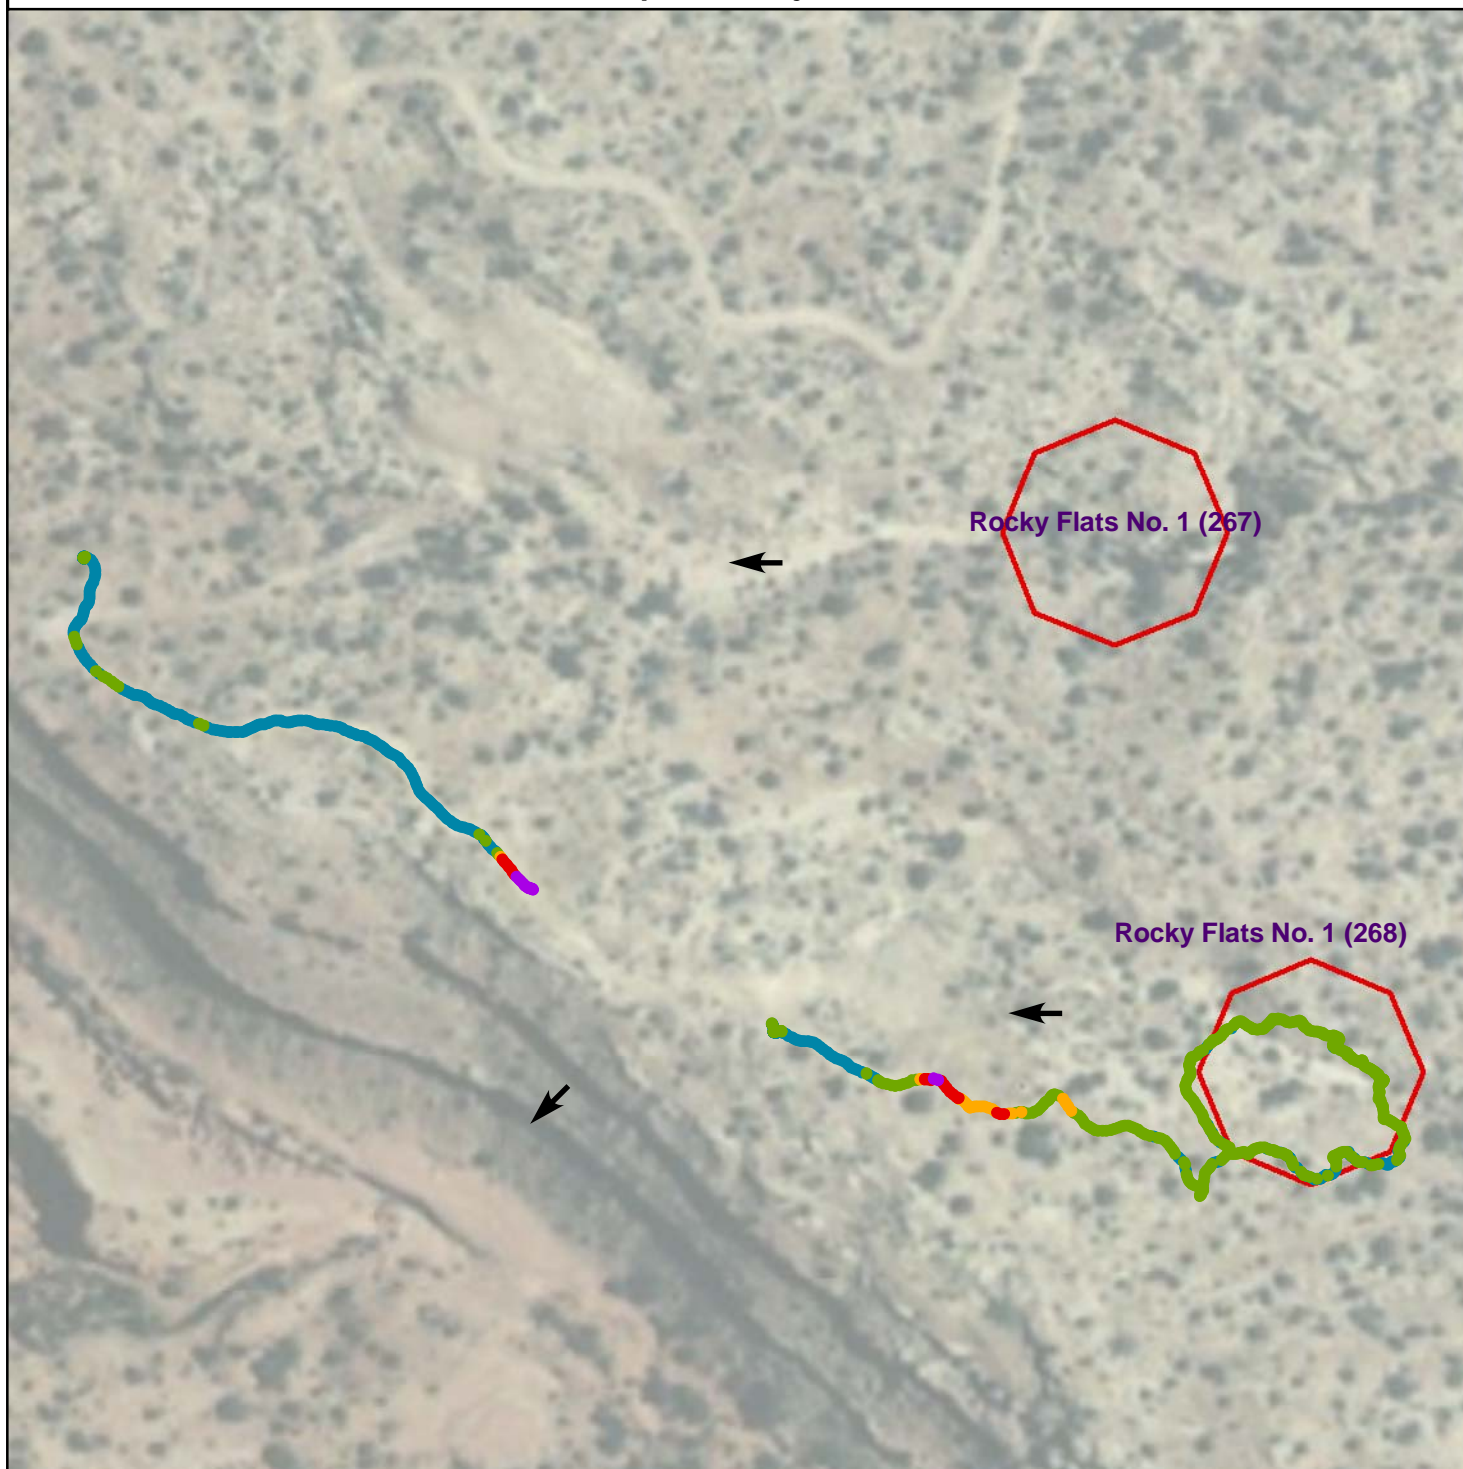
Figure 9 - Gamma Radiation Measurements
Rocky Flats No. 1 (268)
Beclabito Chapter, Navajo Nation, Arizona

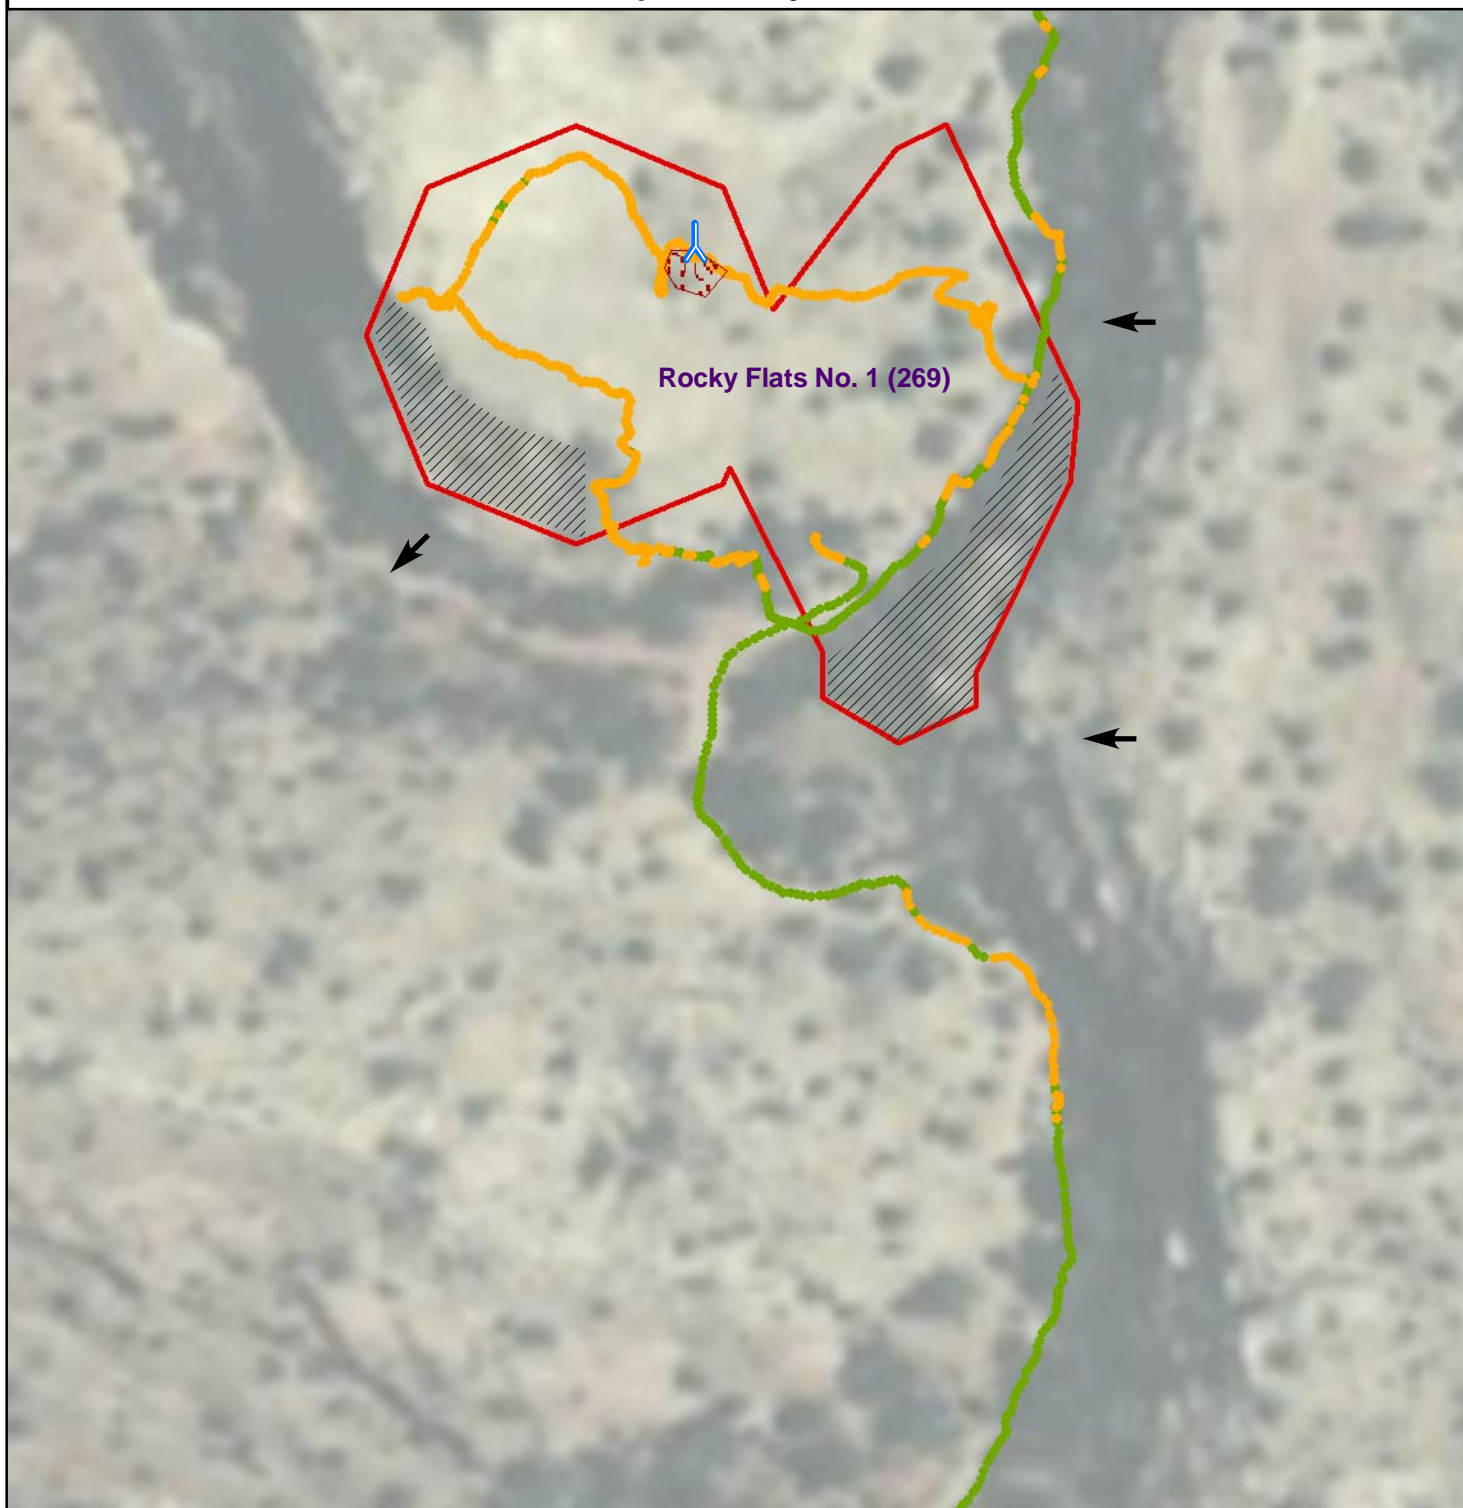
A total of 1,723 gamma radiation measurements were collected from the mine site, ranging from 7,593 cpm to 107,513 cpm. Measurements collected at the adit and waste pile were found at levels above 100,000 cpm. The measurements are represented in Figures 10 and 11.

**Figure 10 - Gamma Radiation Measurements, Above Two Times Background
Rocky Flats No. 1 (269)
Beclabito Chapter, Navajo Nation, Arizona**
